# 2 Wind turbine tower collapse due to flange failure: FEM 3 and DOE analyses

4 Mar Alonso-Martinez <sup>a\*</sup>, José M. Adam<sup>b</sup>, Felipe P. Alvarez-Rabanal<sup>a</sup>,

23 **Keywords:** Wind tower; Collapse; Failure; Design of experiments; Finite element modeling

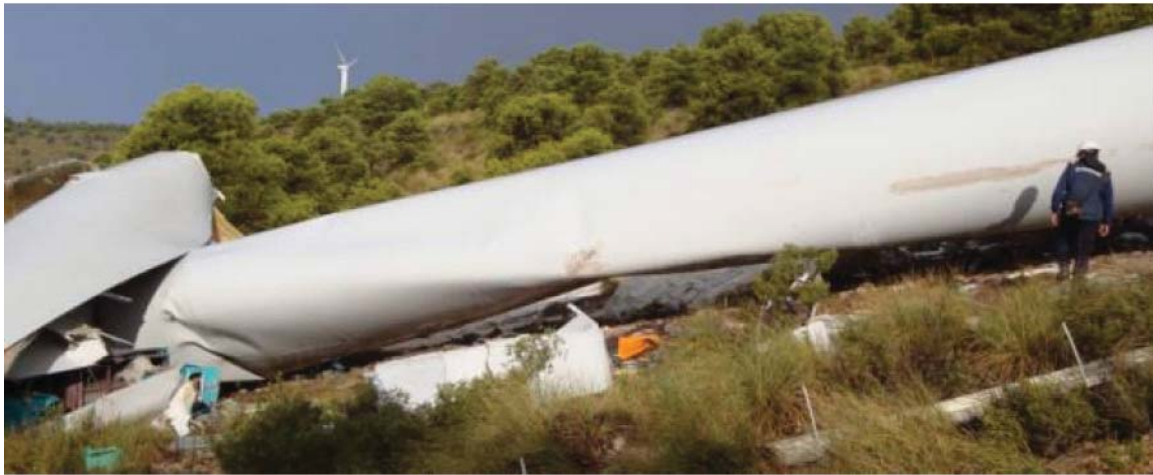
*Fig. 3. View of the tower the day after collapsing*

99 Firstly, the joint between the tower and the nacelle was seen to be in good condition with no evidence  
100 of damage at this location having caused the failure. Secondly, the steel tube was buckled, as can be  
101 seen in Fig. 3. Thirdly, the blades were seen to have damaged the steel tubes during the fall. After the  
102 inspection, the most probable cause was therefore identified as the failure of the base of the tower,  
103 which was made the focus of future tests to find the definite cause of the collapse.

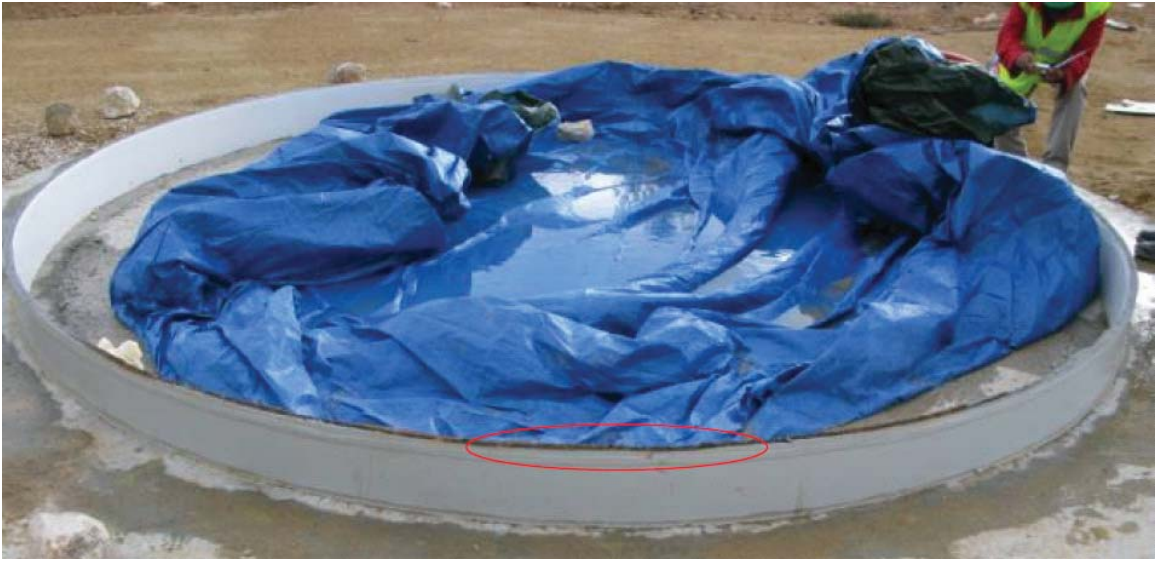
*Fig. 4. View of the section in which the failure began*

105 After the base had been analyzed in greater detail, the failure was located in the lower flange. This  
106 component had been built from a bar of rectangular cross-section, curved and welded S-355-J2 steel

110 The damaged zone (See Fig.4) showed signs of corrosion, which would later be analyzed to identify  
111 the type of failure and its causes. This section was covered with a plastic sheet in order to keep these  
112 zones intact and avoid any deterioration in the material due to the weather subsequent to the collapse  
113 that could possibly lead to errors in the conclusions of the analysis.

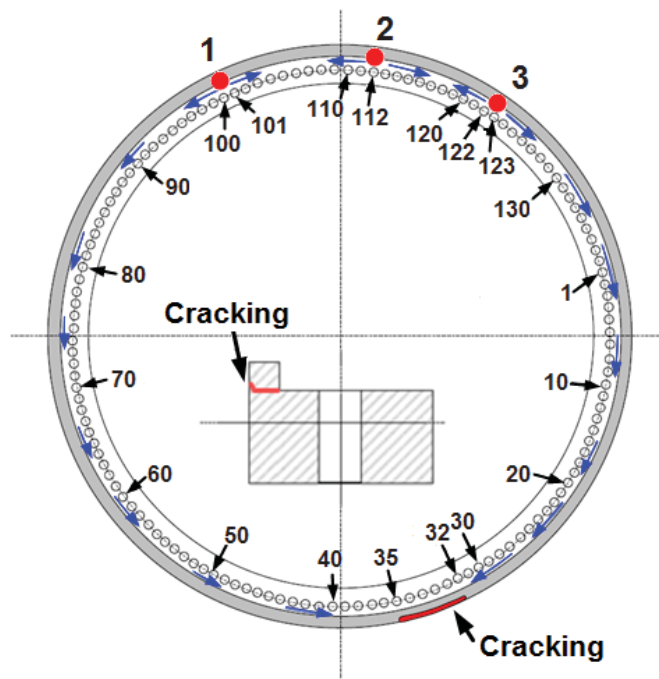
Fig. 5. Detail of the flange and position of the cracks

120 A scheme of the flange studied in this work can be seen in Fig. 5. The flange had been positioned in  
121 order of the drill holes numbered from 1 to 138, number 1 being at the centre of the lower tower access  
122 door. The broken section to be studied in detail was joined to the flange whose scheme is shown in Fig.  
123 5.

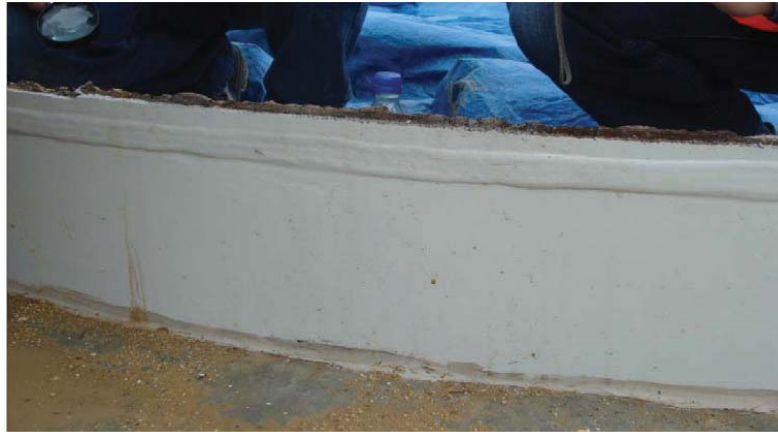
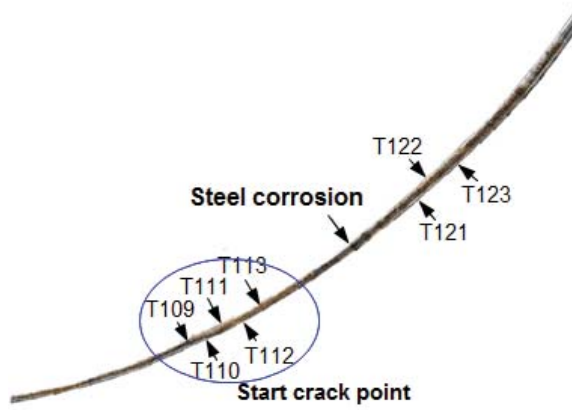
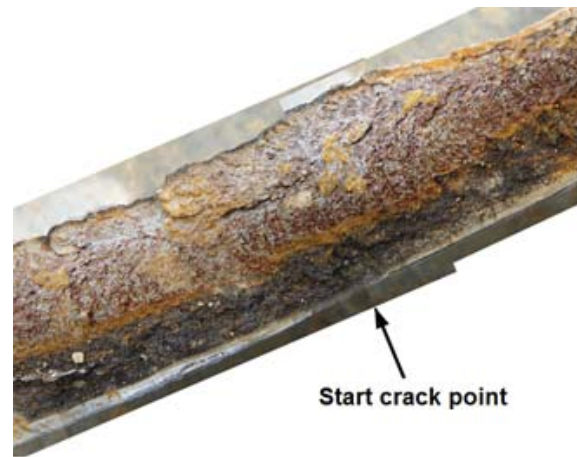
Fig. 6. Detail of the damaged flange section. a) Side view; b) Top view; c) Detail of crack start point

125 The broken section was found to have started and propagated in the base of the flange neck (see Fig.6a).  
126 In photographs taken days after the collapse, various cracks were located in the flange cross-section, as  
127 can be seen in Fig. 6:

- 128 - The initial crack was located between drill holes 100 and 130 (see Fig.6c)
- 129 - Between drill holes 109 and 123 black and blue rust stains were observed (see Fig.6b). These  
130 stains were visible in the on-site inspection and were thus assumed to exist before the collapse  
131 of the structure.

132 In view of the above, the start of the break was considered to date approximately from the time when  
133 the tower had been constructed, due to the oxidation in the broken section.

134 The failure mode observed in the flange provided information to make a preliminary diagnosis of the  
135 collapse that would later be verified by experimental tests and numerical analysis. This diagnosis  
136 identified the initial crack that did not spread any further and that could have been due to the forces  
137 induced by the bolt pretension or also possibly by a crack in the flange due to an impact during its  
138 installation in the tower.

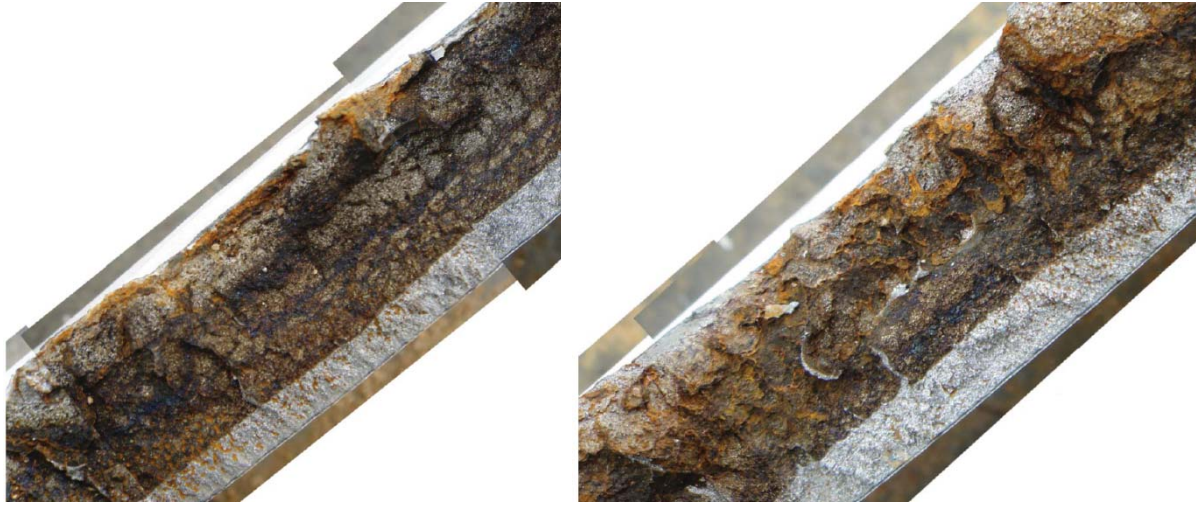
*Fig. 7. Detail of the broken flange section*

141 The detailed analysis of the oxides found in the damaged section included a large amount of blue oxides  
142 organized into bands or groups of points (see Fig. 6c and Fig. 7) characteristic of the so-called *blue*

143 *brittleness* or *brittle martensite*. The former is often found in most steels and is due to the transformation  
144 of austenite into cementite at the grain boundaries when the material is subjected to temperatures around  
145 300° C. The decomposition of the austenite seriously reduces the toughness of the material. This type  
146 of brittleness is accentuated by the segregation of impurities at the grain boundary, which promotes the  
147 intergranular breaks typical of brittle fractures [19] and [20]. Some authors have observed that blue  
148 brittleness when combined with corrosion cracks can cause disastrous failures in steel components [21–  
149 23].

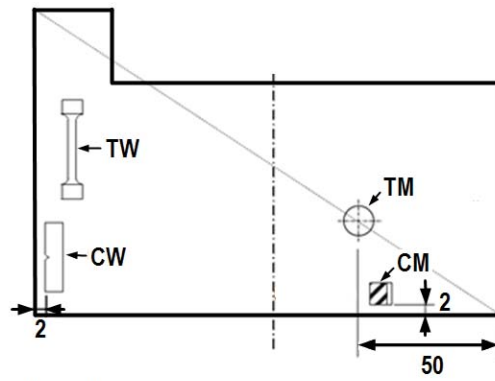
Fig. 9. Detail of the specimen extraction zone [23]

168 In view of the type of failure discovered in the flange, close to the welded zone, the material was  
169 analyzed to obtain the fracture toughness parameters. Three Charpy specimens were extracted from the  
170 flange between drill holes 112 and 114, as shown in Fig. 9 [24].

179 Since the value was below the 27 J given in the EN10025-3 Code [18], it was therefore concluded that  
 180 the fracture toughness of the material was unsatisfactory in all directions. In view of these results, a  
 181 serious weakness was identified in the material that could have been responsible for unforeseeable  
 182 failures in the behavior of the structure. The experimental results show that the material does not possess  
 183 the properties required by the current code and this anomaly could have caused the abnormal behavior  
 184 of the structure that had not been considered in its design.

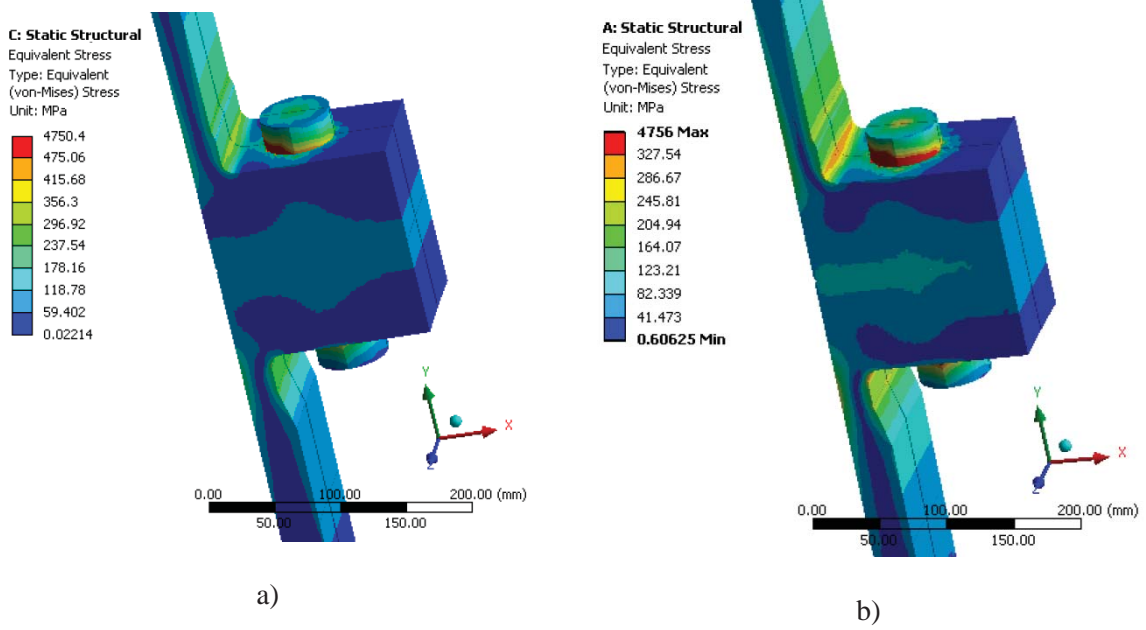
Fig. 14. FEM model results, equivalent Von-Mises stress. a) applying bolt pretension only (in Pa); b) for all applied loads (in Pa)

326 The results obtained from the numerical simulations provided interesting information for an exhaustive  
327 analysis of the tower failure. On analyzing the stresses in the joint it was seen that the prestressing of  
328 the bolts, before considering the other loads, exerts high forces on the joint, as can be seen in Fig. 14a,  
329 since the flange steel's yield strength is exceeded. As a result, the flange is already in a highly stressed  
330 state even before the other loads on the structure are taken into account.

331 After applying loads on the structure, the numerical model showed a high concentration of stresses on  
332 the flange neck that coincided with the point of the failure observed in the visual inspection. After  
333 analyzing the results of the numerical model, it is shown that the Maximum Von-Mises stress exceeded  
334 the material's yield strength (see Fig.14b).

444 In the present case, the failure could have been avoided if the material used in the flange had been  
445 subjected to the appropriate quality control (toughness test). It could also have been avoided had the  
446 flange been better designed to remove the maximum service stress away from the zone affected by the  
447 welding, e.g. with a larger chord radius and longer neck.
