# 2 Wind turbine tower collapse due to flange failure: FEM 3 and DOE analyses

4 Mar Alonso-Martinez <sup>a\*</sup>, José M. Adam<sup>b</sup>, Felipe P. Alvarez-Rabanal<sup>a</sup>,

23 **Keywords:** Wind tower; Collapse; Failure; Design of experiments; Finite element modeling

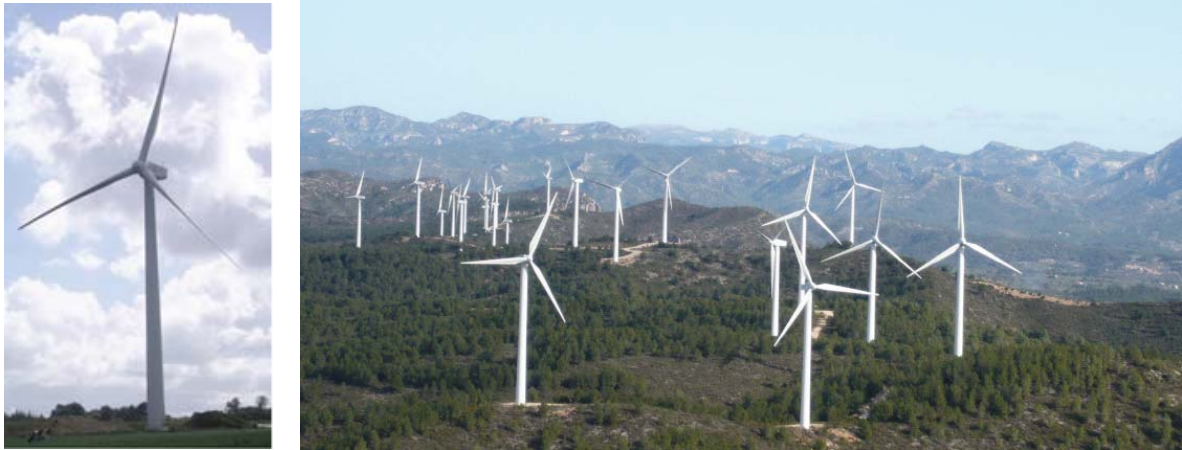
*Fig. 1. General view of the Abuela de Santa Ana wind farm and one of the towers*

75 The *Abuela de Santa Ana* onshore wind farm is located near the town of Pozo Llorente in the province  
76 of Albacete (Spain). It consists of 25 GE Energy 1.5sle Model 1.5KW wind turbines, the diameter of  
77 the rotor is 77m and the height of the tower varies between 61.4m and 85m. It is operational at the  
78 present time under the control of the ACS Company at a nominal power of 37.500 kW. Its geographic  
79 coordinates are 39° 4' 36.5" latitude and -1° 30' 23.5" longitude. A view of the wind farm with a close-up  
80 of a tower can be seen in Fig. 1.

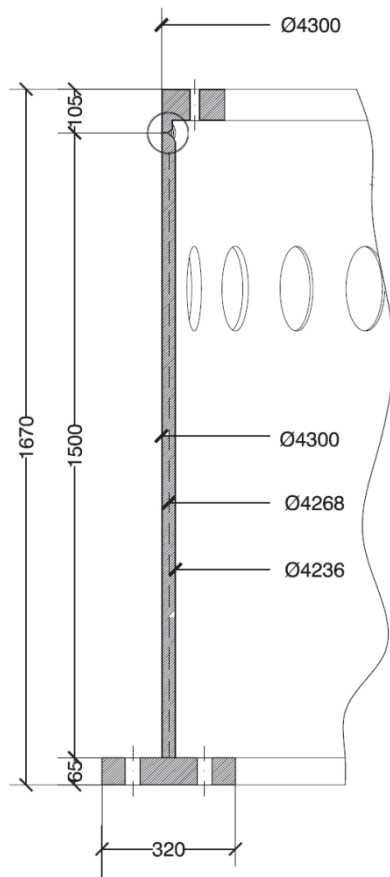
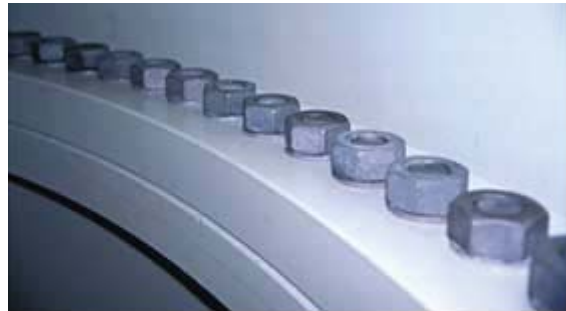
Fig. 2. Details of the tower/foundation connection. a) Detail of lower flange and foundation; b) Detail of flange and bolts. Source: [16]

82 The turbine towers are composed of different steel tubes and the flange is fixed to the lower tube and is  
83 embedded in the foundations (see Fig.2). The tower tubes are bolted together and are required to  
84 maintain the necessary stiffness to support the turbine nacelles fixed to the top of the tower.

85 The flange is placed in the lower part of the tower. The flange is a steel tube 1.67 m long and 4.3 m  
86 diameter. It consists of the following components (see Fig. 2):

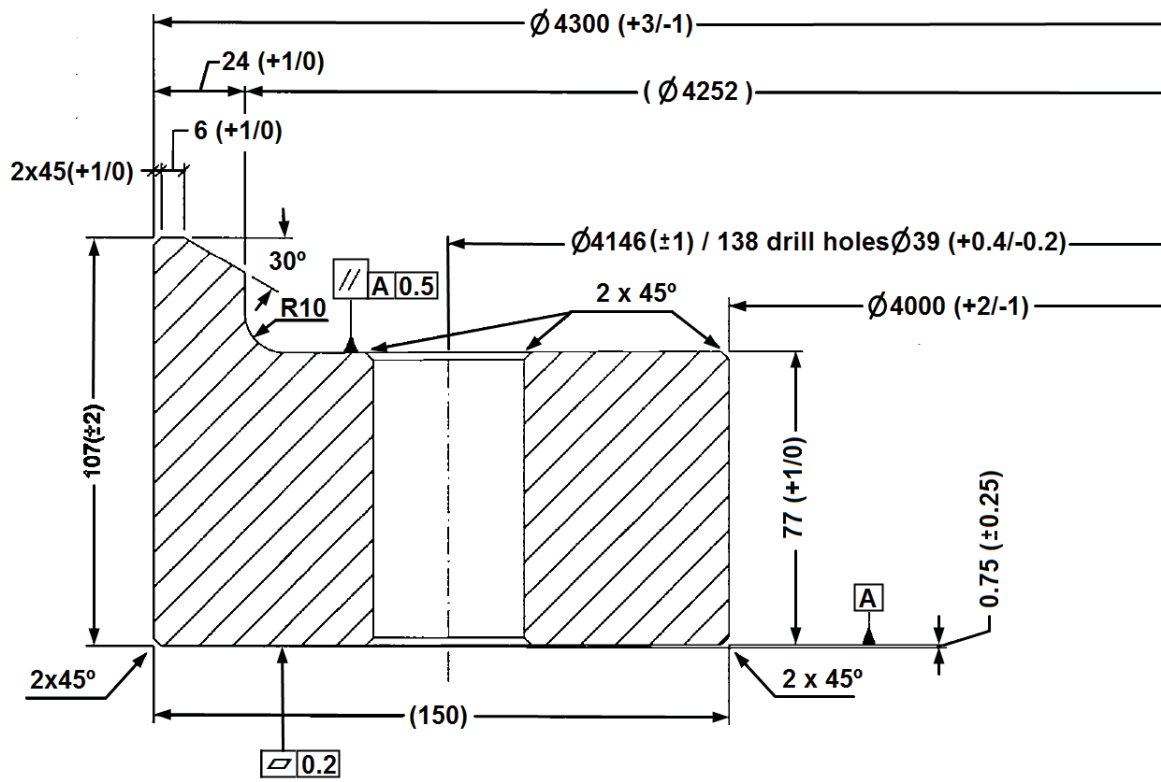
Fig. 8. Geometry of flange section

156 The flange dimensions are as follows: 4.3 m. external diameter, 0.107 m. maximum thickness, and 0.15  
157 m. in width, with 138 drill holes of 0.039 m. in diameter. The section geometry and tolerances are given  
158 in Fig. 8.

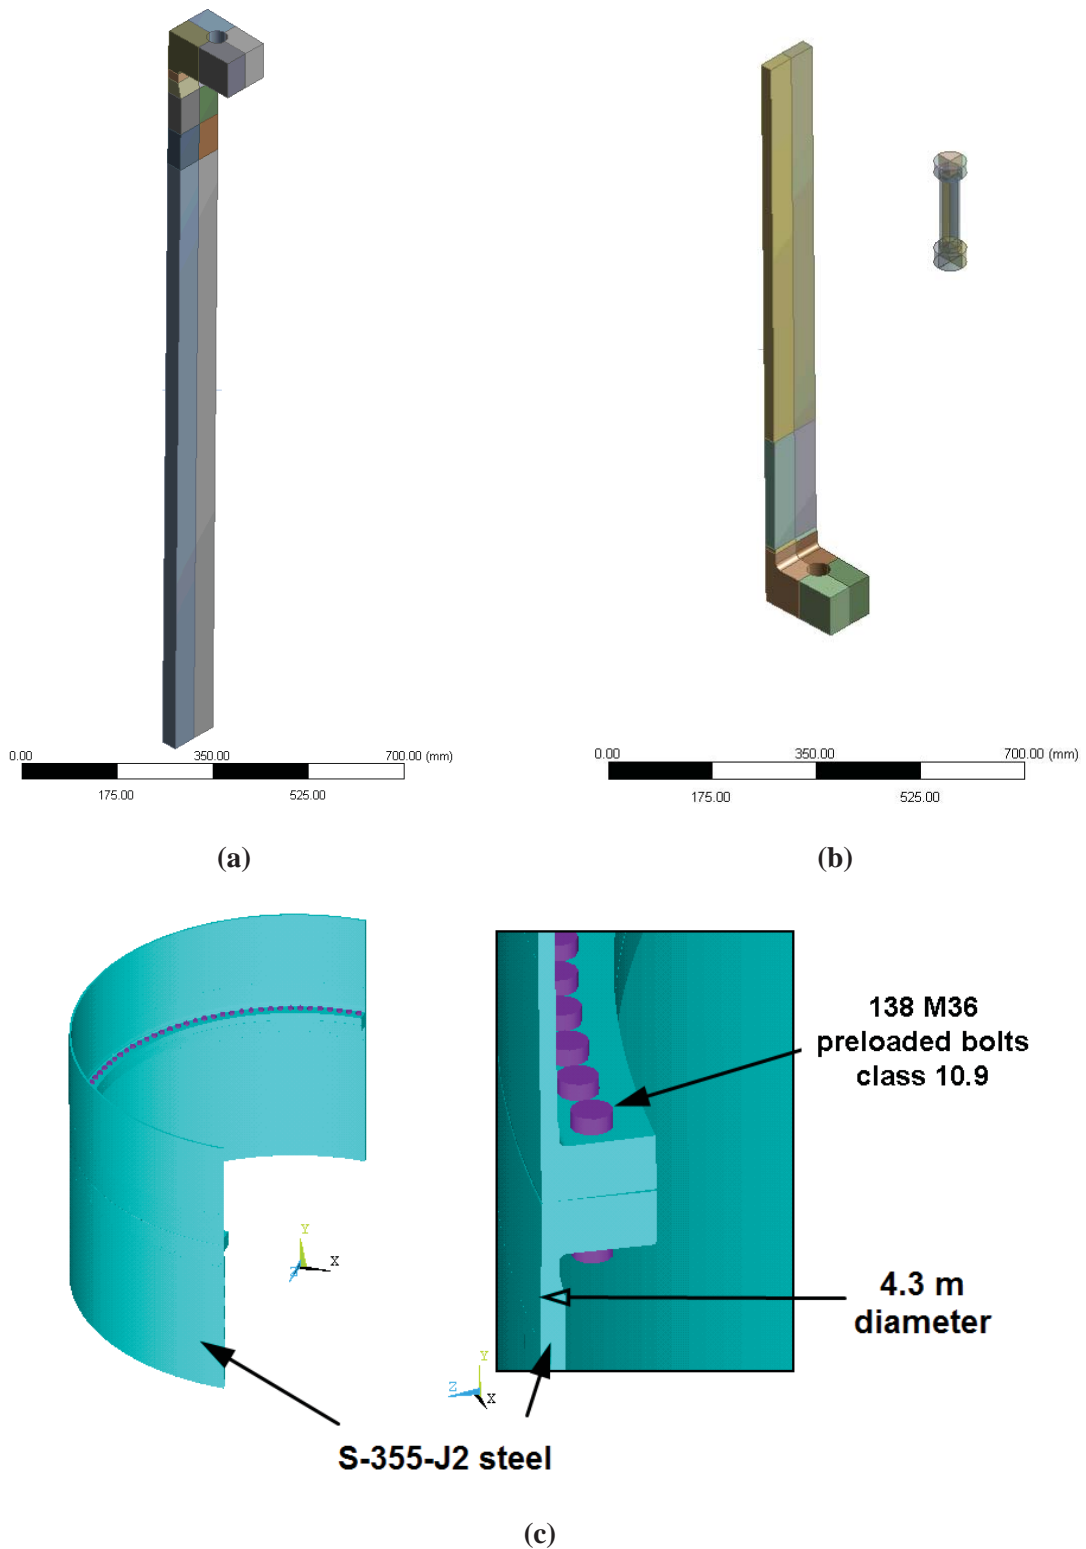
Fig. 10. Geometric model: a) Lower flange; b) Upper flange and bolt; c) Complete (symmetry) model.

203 The geometrical model studied consisted of the lower flange, the upper flange and a bolt joining both  
204 parts, to which symmetry conditions were applied in order to reduce the computational cost of the  
205 models. Details of the model geometry can be seen in Fig. 10.

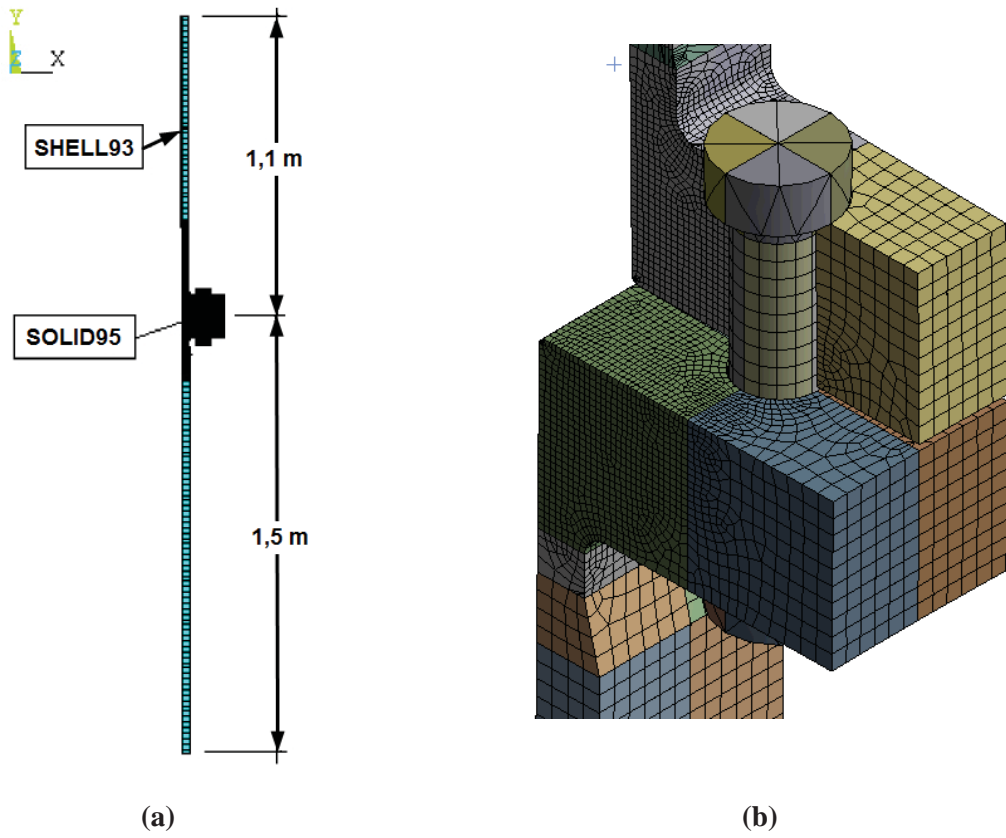
Fig. 11. Finite elements mesh: a) General view; b) Detail of the mesh in the bolt

210 SOLID95 type finite elements were used for the flange and SHELL93 for the steel tube at a distance  
211 from the joint (see Fig.11a). These elements are suitable for modelling curved zones and complex  
212 geometries, as in the case under study [25–27].

219 The mesh size was minimum 0.0013 m and maximum 0.27 m, with a total of 266.194 nodes and 71.117  
220 elements. As can be seen in Figure 11b, certain zones of the geometry were modelled with a very fine  
221 finite elements mesh due to the curves and transitions between the elements.

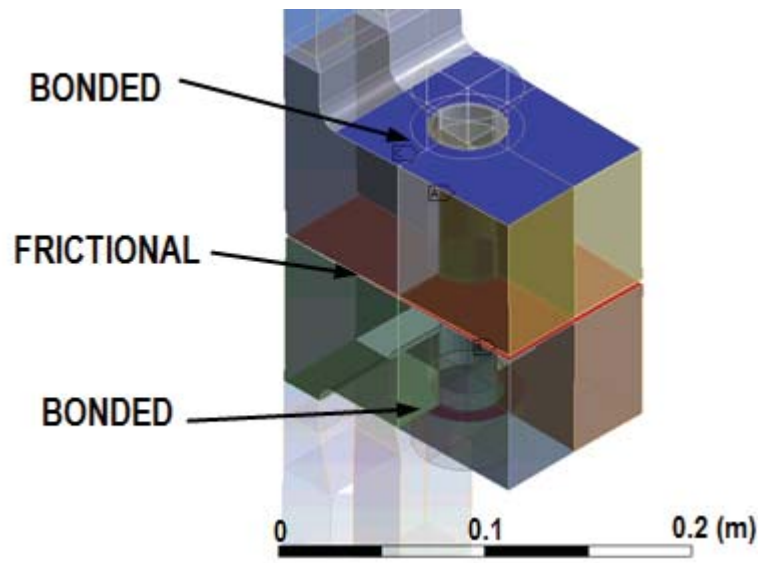
*Fig. 12. Contacts in model*

226 The model was completed with the configuration of the contact between elements and the application  
227 of boundary conditions, which consisted of frictional contact between the flanges surfaces and bonded  
228 contact between the bolt head and the upper flange surfaces and for the nut with the lower flange  
229 surfaces (see Fig.12). The friction coefficient considered was 0.1, adopting an Augmented Lagrangian  
230 formulation [30].

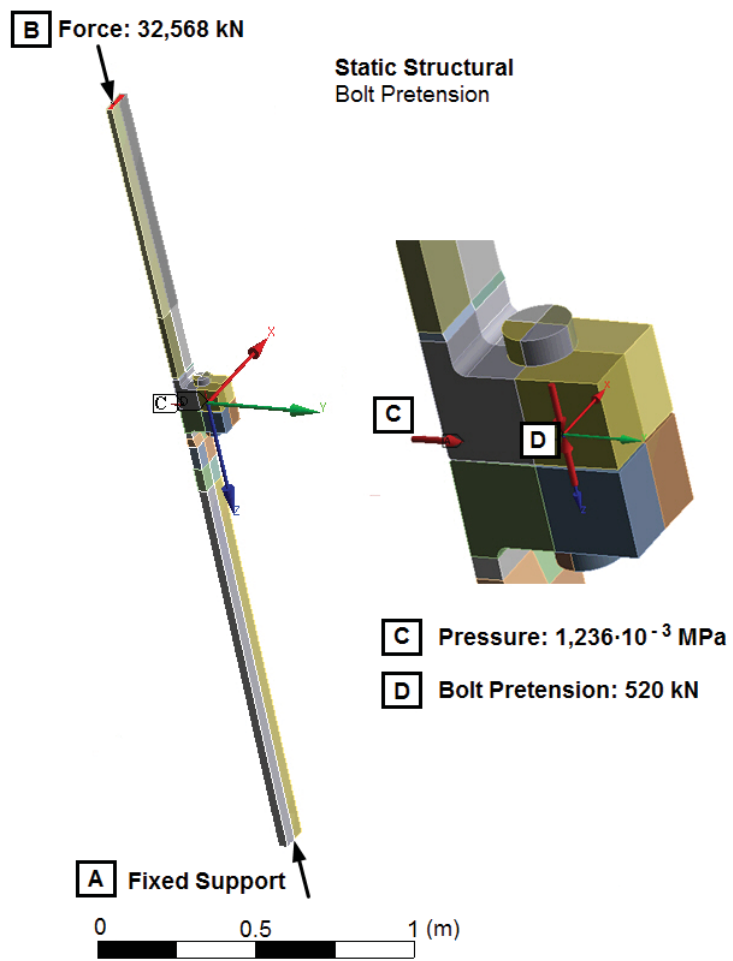
Fig. 13. Boundary conditions used on a section of the flange

237 To begin with, use was made of the flange symmetry to simplify the model and represent the actual  
238 continuity of the tower shell and flanges. In this way, only a 1/138<sup>th</sup> sector of the flange was simulated  
239 and symmetry conditions were applied (see Fig. 13). Secondly, a restriction was applied on the

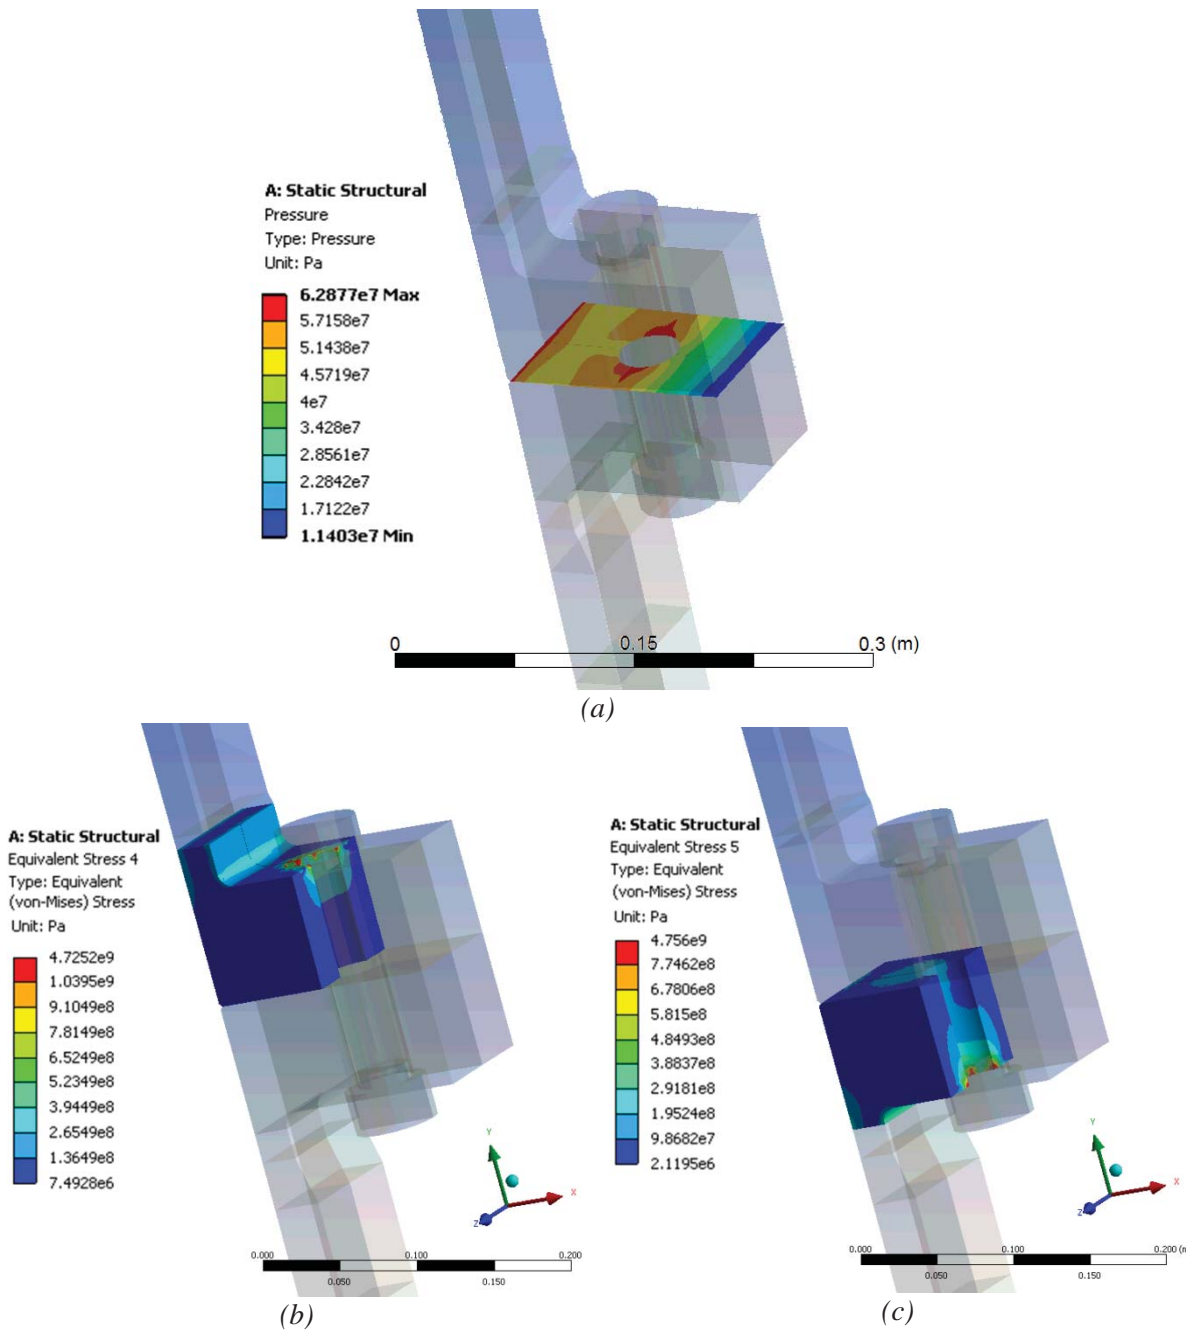
Fig. 15. Results of the FE model and DOE analysis: a) Contact stress between upper and lower flanges (in Pa); b) Von Mises stress in upper flange (in Pa); c) Von Mises stress in lower flange (in Pa)

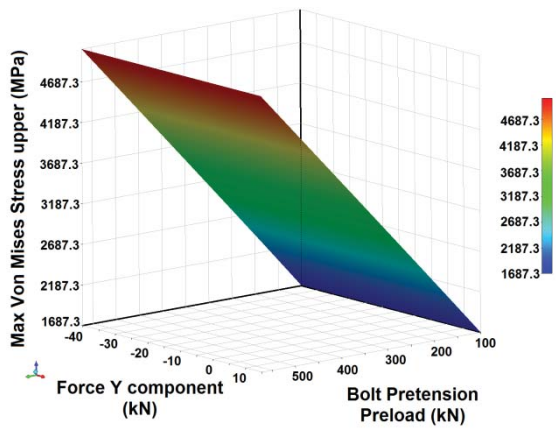
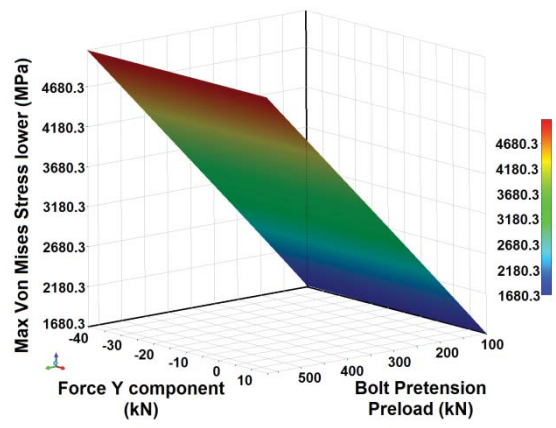
Fig. 17. DOE analysis: External part of the flange (upper and lower part. a) Bolt pretension vs Force Y in upper part of the flange; b) Bolt pretension vs Force Y in lower part of the flange

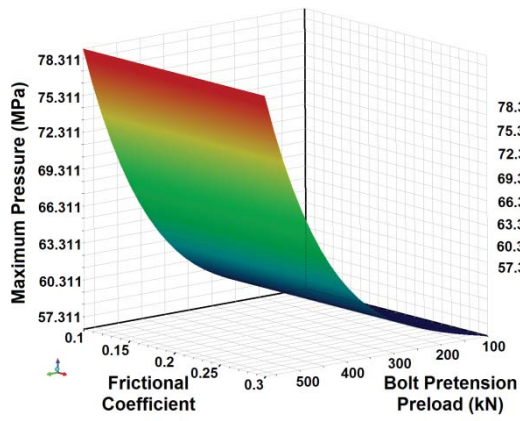
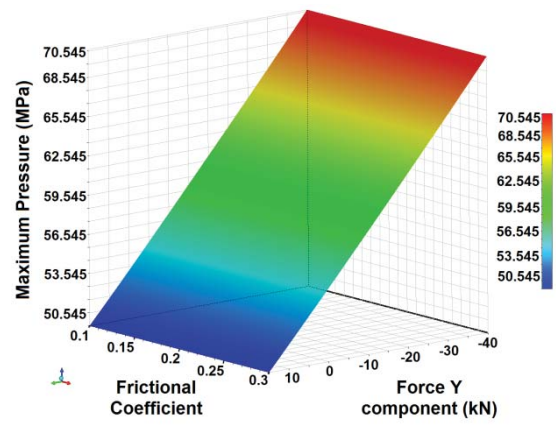
**Fig. 18.** DOE analysis: maximum pressure in contact between the flanges: a) Contact friction vs Bolt pretension; b) Contact friction vs Force Y.
